## Inspector Secrets - Kick Out Flashings

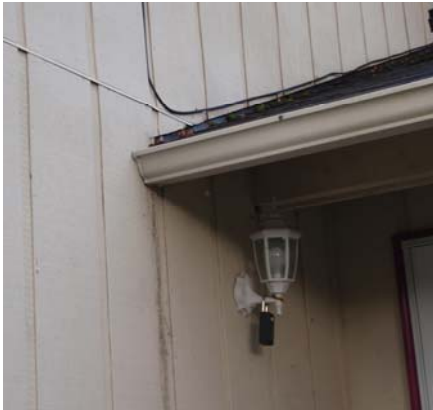
The roof to wall intersection often has a missed flashing detail called a Kick Out flashing. This is the very last metal flashing detail above the gutter where it meets the wall. On the left you can see the water marks below the gutter end, a clear indication of a missing Kick Out flashing.

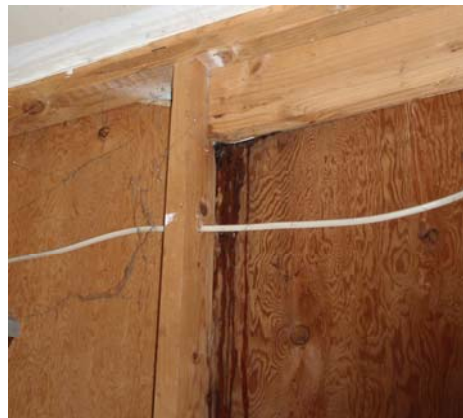
On the right one can also see water draining behind the siding. The garage was unfinished allowing an unobstructed view of what was occurring.

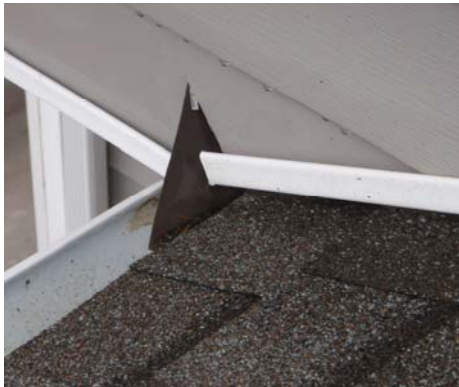
This is what a kick out flashing looks like. Notice the "dog ear" which will direct water into the gutter instead of behind the wall.
