A Home Inspector's Journal: Plumbing Leaks and Plumbing Failure

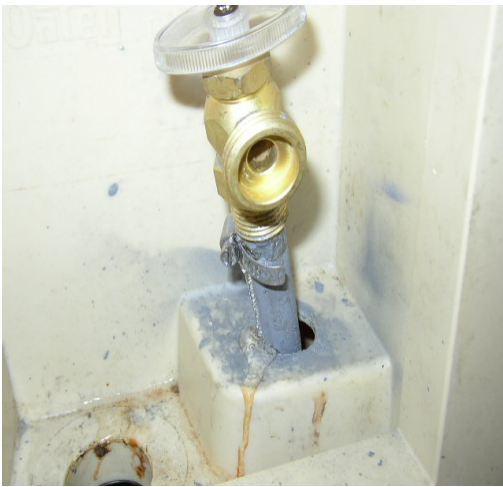
In the first photo, there is an active leak from the washing machine supply line which in this case was easily seen because all of the appliances were gone. The presence of the pipe clamp indicates someone had tried to fix the leak at some time, obviously to no avail. This particular type of supply pipe, called Polybutylene, or PB, is known for having leaks at the fittings, which would seem the obvious case here. (PB pipe was also the subject of a \$950 million class action settlement which may offer relief to homeowners who have this type of pipe. Further information is available at www.pbpipeline.com).

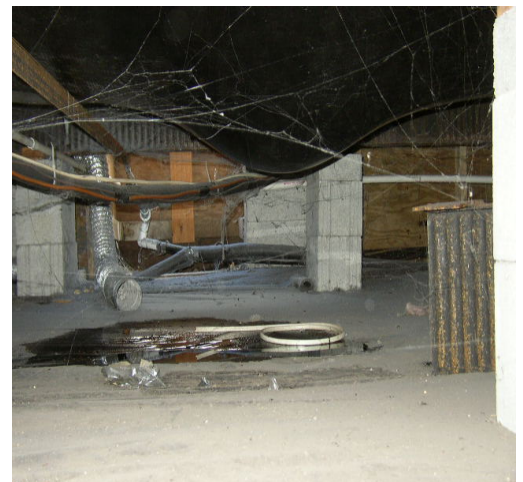
The second photograph shows the view from beneath the laundry room. Because the structure is a manufactured home, there is a plastic belly wrap or barrier all along the bottom of the structure. In the top of the photo this plastic barrier has filled with water from the leak essentially creating a huge water balloon about four feet across. The water is leaking out onto the ground, but a significant amount still remains trapped between the plastic and the floor above. Repairing the leak is just the beginning as the plastic belly wrap will also need to be

opened up for evaluation. The sub-floor insulation will clearly need to be replaced, but there may also be hidden conditions beyond that: Among these could be wood rot to the sub-floor or floor joists, infestation of wood destroying insects and even mold. All from one leaking pipe.
