Alpine Window Failure

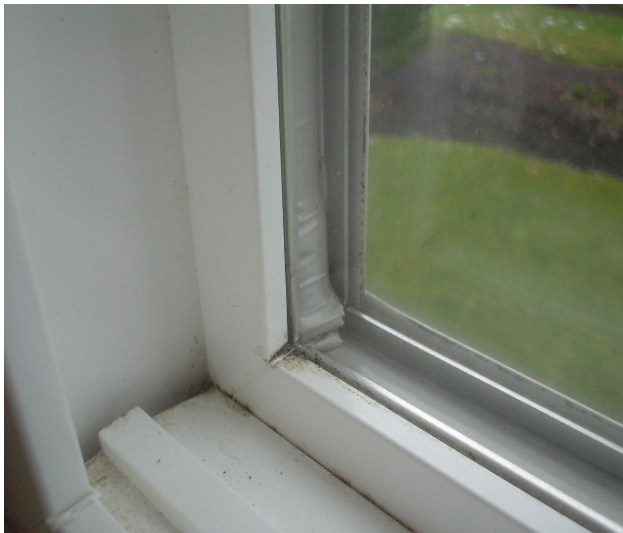
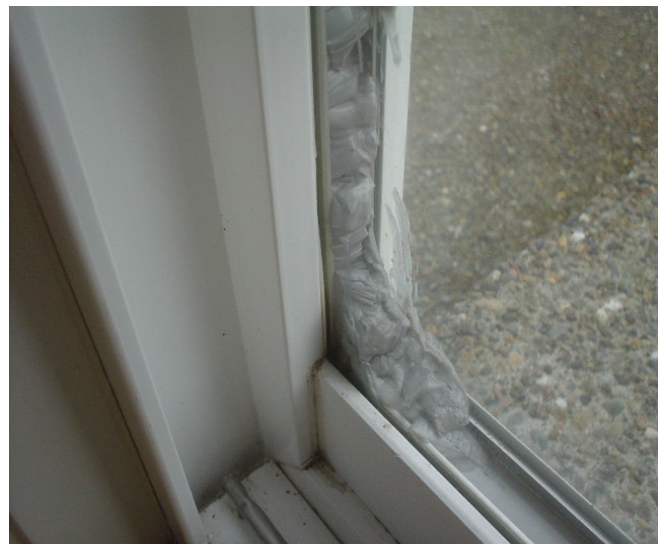
Many of us in the field have been seeing an unusual failure with Alpine double pane vinyl windows. As the pictures below will show, this failure has been manifested by a breakdown of the gray sealant material between the panes. In some cases it is so severe the sealant material looks melted. This condition is indicative of general window failure, (typically called steaming or fogging, where water vapor becomes trapped between the panes), and replacement is indicated.

Alpine windows are no longer made and the company was bought out by Alside Building Products about two years ago. The Alpine name is clearly visible on the interior window frame.
