Inspector Secrets - Roof Leaks

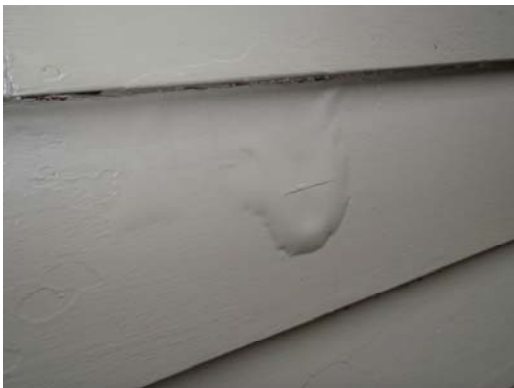
Based on my experience, roof leaks happen #1 around penetrations, #2 in valleys and #3 in the field. If it is a tile roof, the #1 leak source is in the valley with penetrations being #2. Remember that gravity will pull water downward as far as it can. Therefore the manifestation of a leak may occur where the water gets bottlenecked, often far away from the actual leak source. If you are previewing a home, look around skylights and chimneys for sure. But many times, leaks are manifest along the gutter edge, or above the interior wall on the gutter edge, especially with low pitch roofs such as manufactured homes. That said, a paint sag on an exterior wall, such as shown below, could actually be from a roof leak!
