Home Inspector's Notes: Wood Boring Beetles Can Cause Serious Damage

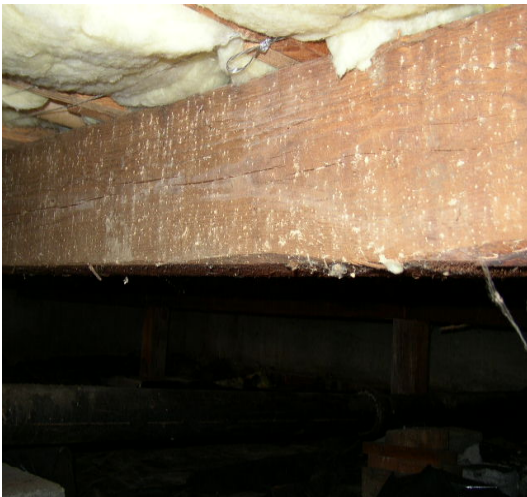
The first photo shows a beam in a sub-structure crawl space which is manifesting a very substantial infestation of deathwatch beetles. The beam is literally riddled with small bird-shot sized holes that have fine powdery wood sawdust or frass coming out of them. Seeing this frass in and beneath the small emergence holes indicates this is a very active infestation.

Because these beetles also require moisture to survive, it is important to make sure the sub-structure crawl space is adequately covered with plastic vapor barrier and that there is adequate crawl space ventilation. Foundation vents should never, ever be plugged or blocked. Lastly, in the case outlined here, a licensed applicator was called to provide chemical treatment.

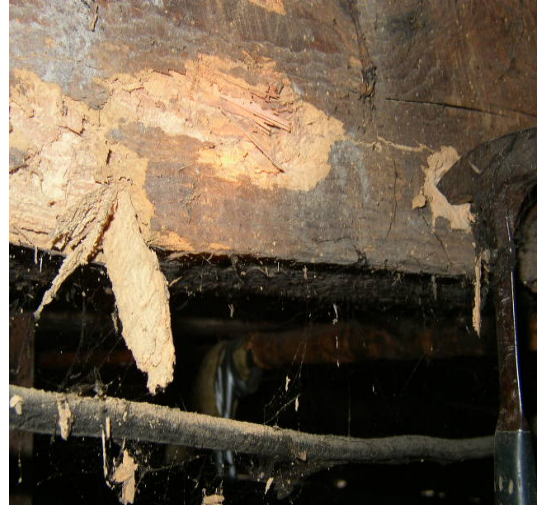
In the second photo, the damage is clear as the rock pick easily breaks through and stays imbedded in the beam. Much of the wood has been reduced to fine powder and the beam will need to be replaced. It is also important when performing repairs that if any damaged wood needs repaired, it should be removed completely. The practice of installing new wood adjacent to damaged wood (called crippling or sistering) is not a good practice when dealing with these types of beetles as they may then re-infest and damage the newly installed wood.
